Restoring Ford 9N-90:

A Tractor for a Working Farm, by Joel Wilbur

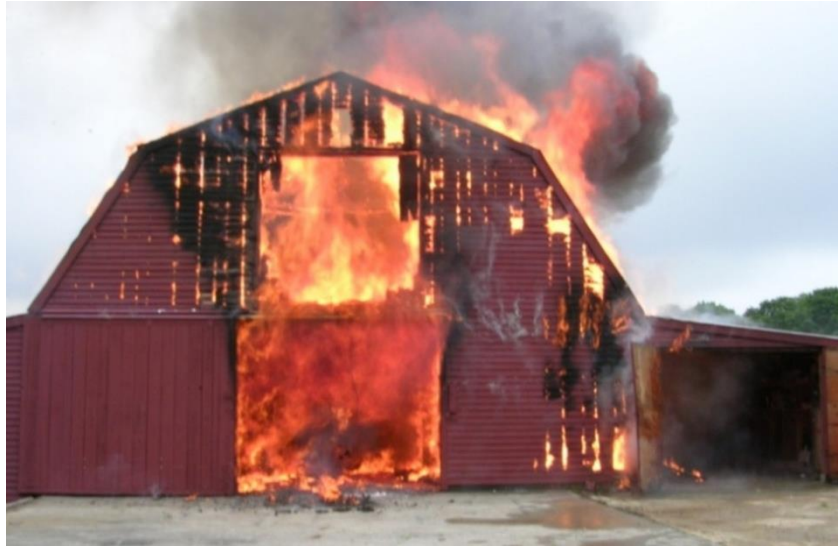
In 2009, a devastating barn fire occurred - but, thankfully, we had a bunch of old quilts draped over the hood, and thanks to the quick response of the local fire departments, they were able to keep enough water on it so that 9N-90 wasn't totally destroyed.

Needless to say, this fire set back the restoration by a few years. Finally, in May of 2012, my father and I began restoration on 9N-90.

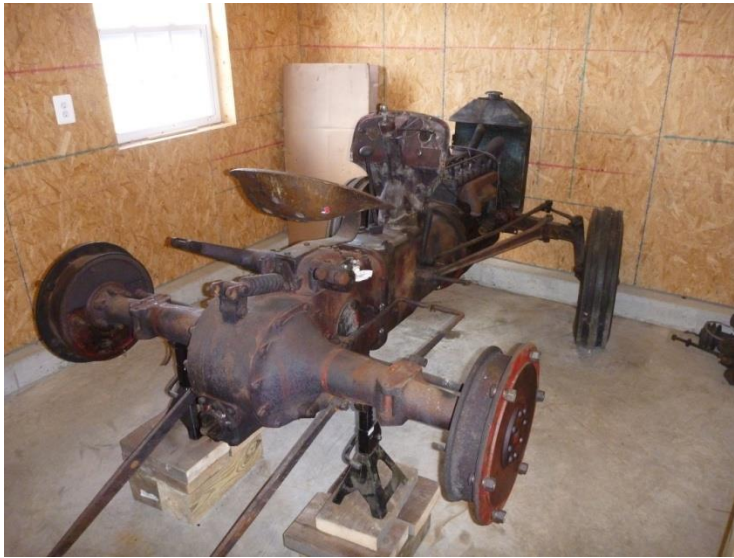
Disassembly is always the easiest part of the project - the hard part is remembering how it goes back together. Within two long days, we had 9N-90 stripped down to just the castings. This included the removal of the Ferguson mid mount PEO 21 mower.

The rear axles and trumpets were pulled and replaced with smooth axles. Once accessed, we found that the inside of the axle housings, hydraulic pump, and transmission were caked with "mud" from old fluids and simply from sitting for so long. I'm sure the barn fire didn't help this any.

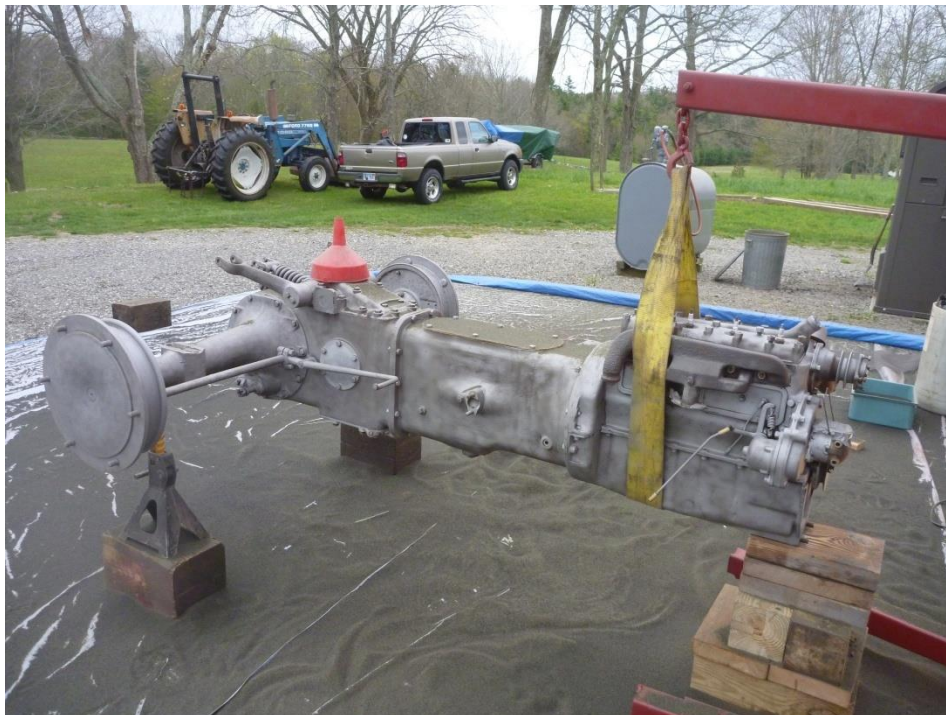
Once we had 9N-90 taken apart, every part was sand blasted down to bare metal - the smaller parts were sand blasted in a homemade blasting cabinet and the larger ones were blasted outside. All cast aluminum parts were blasted with crushed walnut shells to get the pits cleaned out and heavy paint removed. The walnut shells worked perfectly for the aluminum because it did not dig into the aluminum at all, and was a quicker (than by hand) and gentler (than using sand) way to clean it - Of course that was prior to the hundreds of hours we spent sanding those parts later on. 1,500 pounds of sand later and after a day and a half of sand blasting, the tractor was down to bare metal.

After a quick hand sanding and cleaning of all the sand off the tractor, a first coat of self-etching primer was applied to prevent it from rusting.

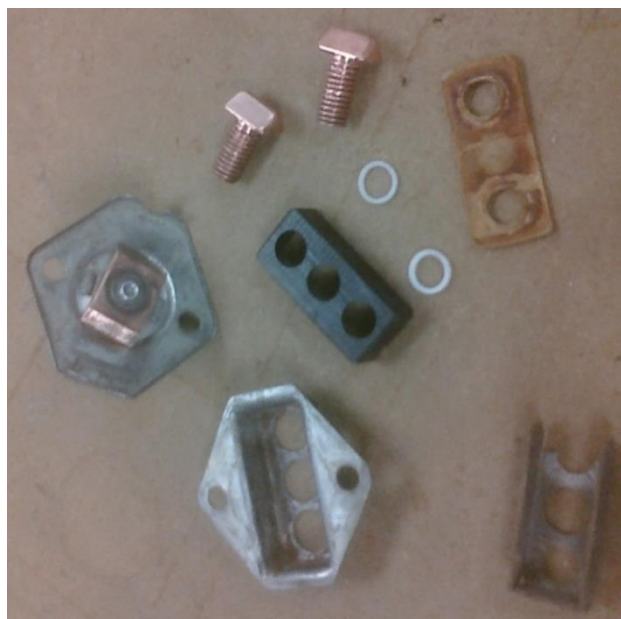
The push button starter switch was in rough shape from the fire- so there was nothing left of the cardboard style circuit protection to keep the two brass studs from shorting out against the casing. Luckily, when I went to the tractor salvage yard I found an early cast aluminum 9N dash with the push button starter switch in the upper left corner - the only difference between this one and the original 9N-90 part was that this dash had the identification tag riveted on the top instead of the casting number (146) engraved. Despite the difference, I ended up buying the entire dash with the push button starter switch because the price was right. After doing a dry fit of the new push button starter switch to the original dash, I noticed many differences. First of all, the push button starter switch had a larger diameter than the original switch so it would not fit in the hole on the dash. The other major difference was that the throat of the push button switch was 3/8" shorter than the original. This made my decision easy - I had to repair the old switch, because I was not going to modify the original dash to make the new push button switch fit. After opening it up, and figuring out how Ford originally designed the switch and used a cardboard insulator for protection, I decided to slightly modify their design. So - off to the mill I went with some Delrin and machined out an internal insert that was identical to the cardboard - I figure this will last a lot longer and we won't have to worry about the switch shorting out over time and causing a fire. I also made some Teflon insulators to fit around the brass studs to keep them centered in the holes and isolated from the casing. I did, however, keep the cardboard isolator on the outside of the switch to keep it looking original- although I did put a small layer of Teflon tape between that and the case as an extra precaution.

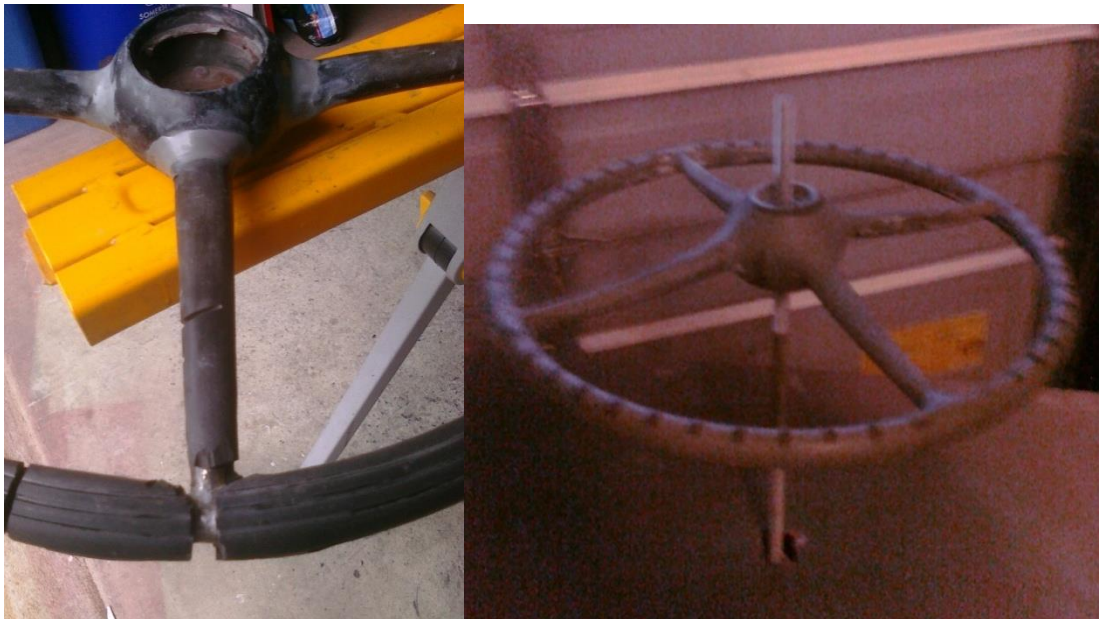
After I discovered an old-timer from NJ who made his living restoring steering wheels, I brought him the 4-spoke wheel to see if he would help me out with it - seeing I have zero experience in steering wheel repair. I now know why he was able to make a living restoring steering wheels: He did great work, but wanted to charge me \$500.00 to restore mine! I told him thank-you but... No. Even though he didn't get my business, he was kind enough to give me some pointers on how to approach restoration. Restoring the steering wheel involved cutting out the majority of the plastic material around all the joints where the spokes meet the outside of the wheel and inside of the wheel. I had to weld three of these joints back together and then, using a putty, re-form the shape of the steering wheel. I cut out many of the sections of the steering wheel where the plastic was chipping away or starting to bubble up: This was an indication there was moisture under it and starting to rust out the metal rods below. I cut the wheel in many locations and applied a putty to re-shape the wheel. After the putty dried, it took many hours of sanding to get the shape just right: 40 hours later, the wheel was complete.

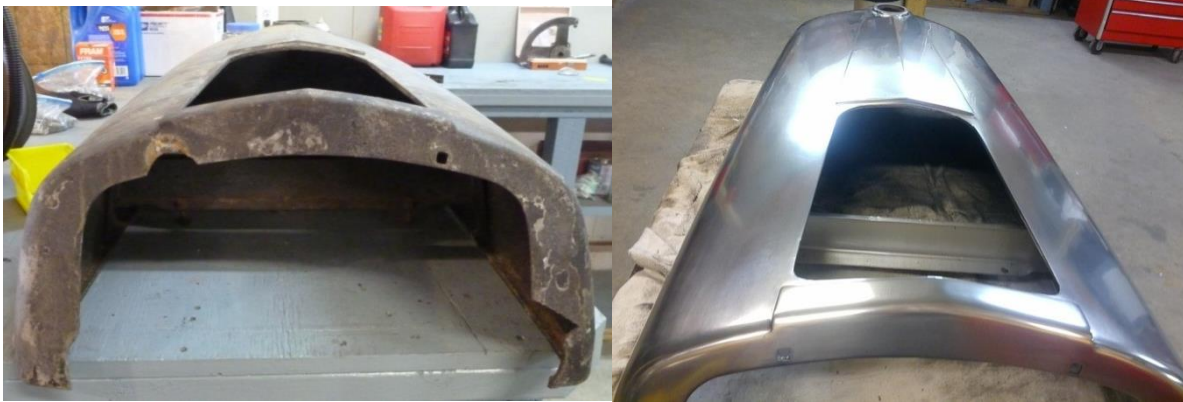
While I was off working on these side - 'detail' projects, my father started sanding down the aluminum hood and preparing it to be repaired by the experts at Sharon Auto Body, located in Sharon, CT. All told, the aluminum hood was in rather good shape having survived a barn fire and after being beaten up over the years: There were three small missing pieces of the hood where it attached to the dash and, prior to our family acquiring 9N-90, it had had a collision with a fence post that completely destroyed the grill and pushed the hood backwards, shattering the dash. Sharon Auto Body's repair is barely noticeable and blends right in. Following the repair, we sanded down the hood, which took many hours: Every time Dad tried to sand out a pitted area, he almost always uncovered a more pitted area. After sanding it out to a 2000 grit finish and adding a coat of Shark Hide Aluminum polish, the hood holds a perfect shine.

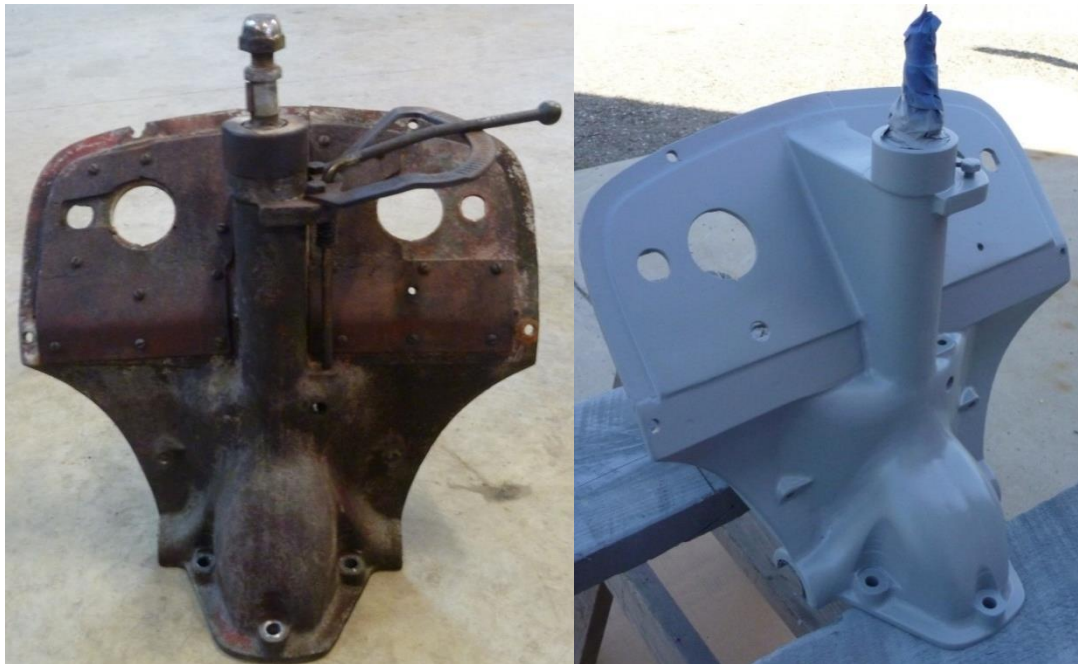
The aluminum dash, with casting number 146 stamped in the top near the steering column, was a little harder to repair than the hood. Before renovation, the dash was being held together by sheet metal and screws placed wherever it was convenient for my grandfather to put them. The repair didn't look good at all, and every collector will cringe when they see the picture of it. Keep in mind, though, that Grandpa's repair worked well for almost half a century and 9N-90 was meant to do work. Although I tried to Tig weld the aluminum dash back together, since the castings were so impure, I kept blowing through tungsten rods and was not able to get a strong bead formed. After giving it a good attempt, we ended up taking the dash to an expert - Ernie Nowakowski in Phoenixville, CT, who was able to get a solid, strong bead along the inside of the dash. He then removed all the sheet metal and screws and welded all the holes.

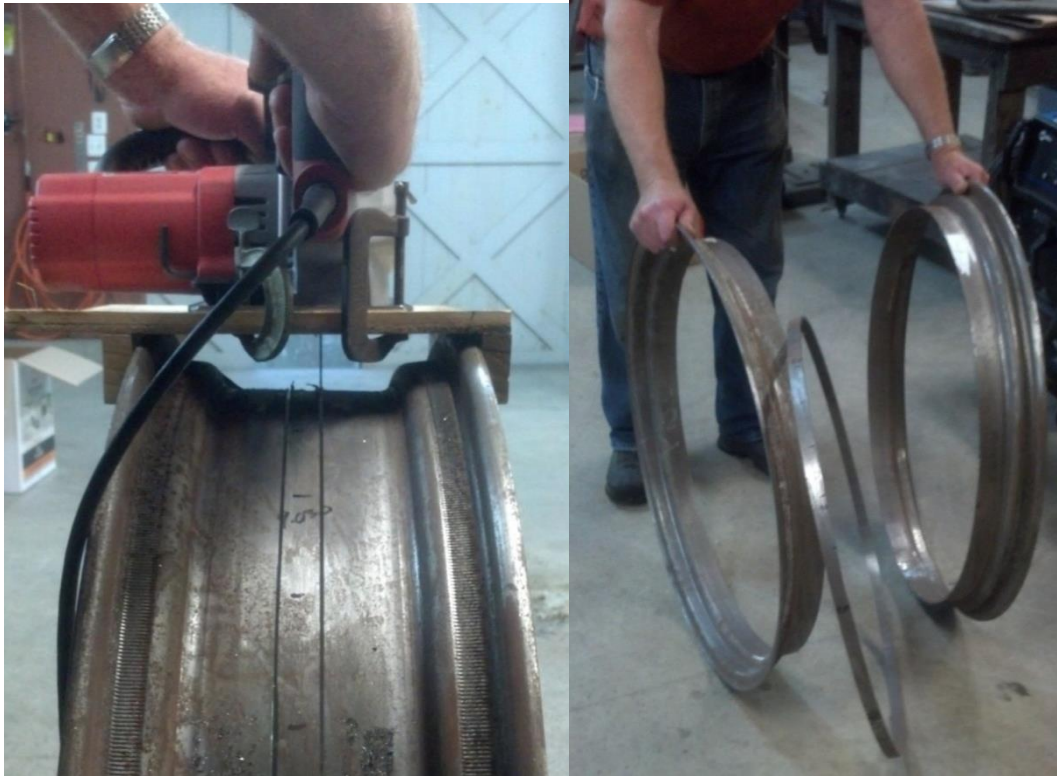
Our next task, and maybe the most innovative, was to fabricate a 32" loop rim. Since we searched for years - even before the barn fire - for a 32" loop rim and had struck out everywhere we looked, we decided to make our own. The original 32" loop rim was beyond repair - we estimate that 40% of the rim was rusted out and missing. It was a miracle it lasted as long as it did. My father found a company out in Missouri that sold a blank 32" rim that had the same profile as the original rim; however, it was over an inch wider than the original 8 inch wide 32" loop rim. So, modifying the blank involved cutting over an inch out of the center of the rim

and then welding it back together to get the proper width. Using my metal cutting skill saw and a homemade jig, we were able to cut the center of the rim out by rolling it across the floor.

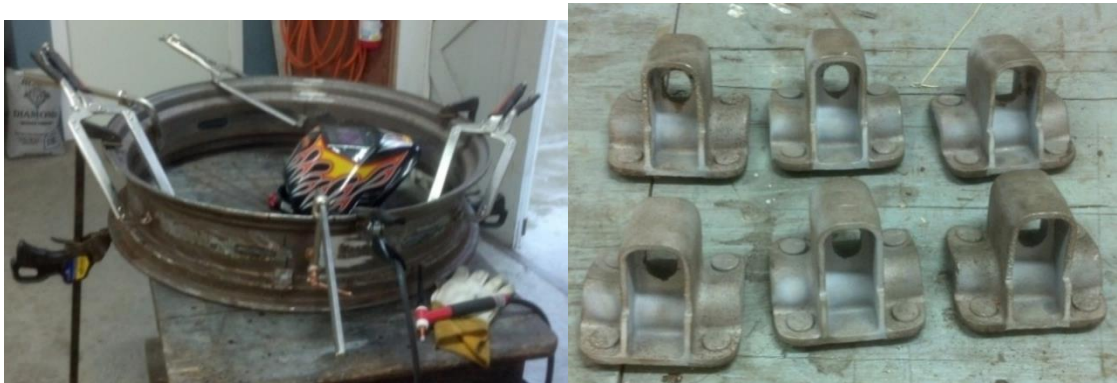
Once the Rim was cut into two pieces, I got to work on clamping it down to my welding table and tig welding it back together, while my father started removing the loops from the old rim.

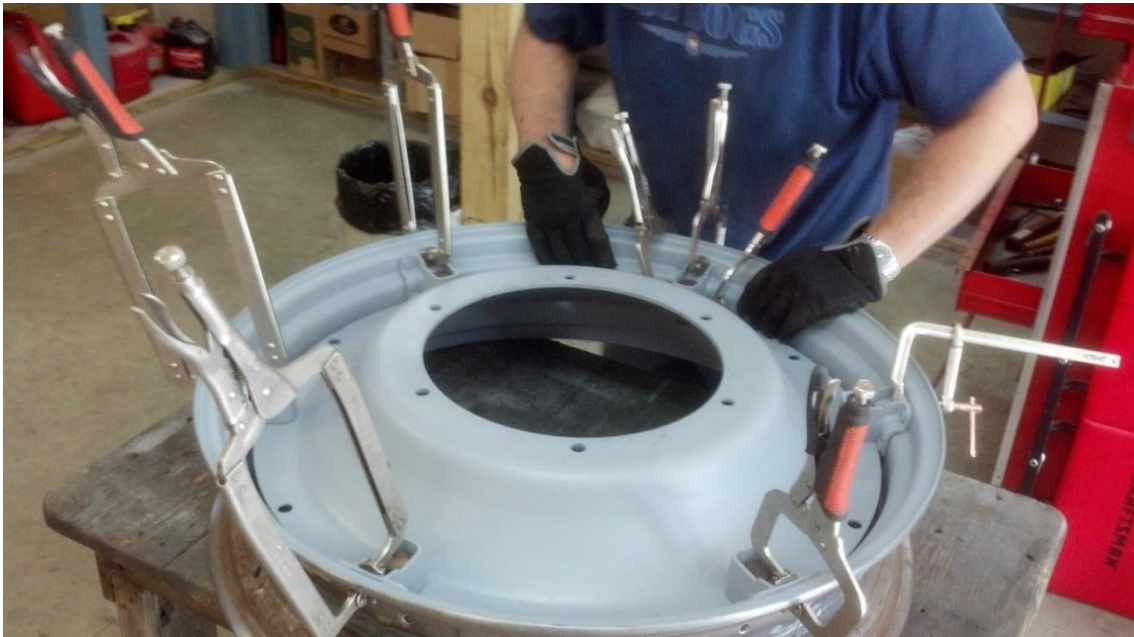
Using the original wheel center and bolting the loops on to it, we got the loops in the proper spot on the rim. We then marked their hole locations and drilled holes in the rim. Then, welding on the loops from the inside gave it the appearance that they were riveted on like the originals.

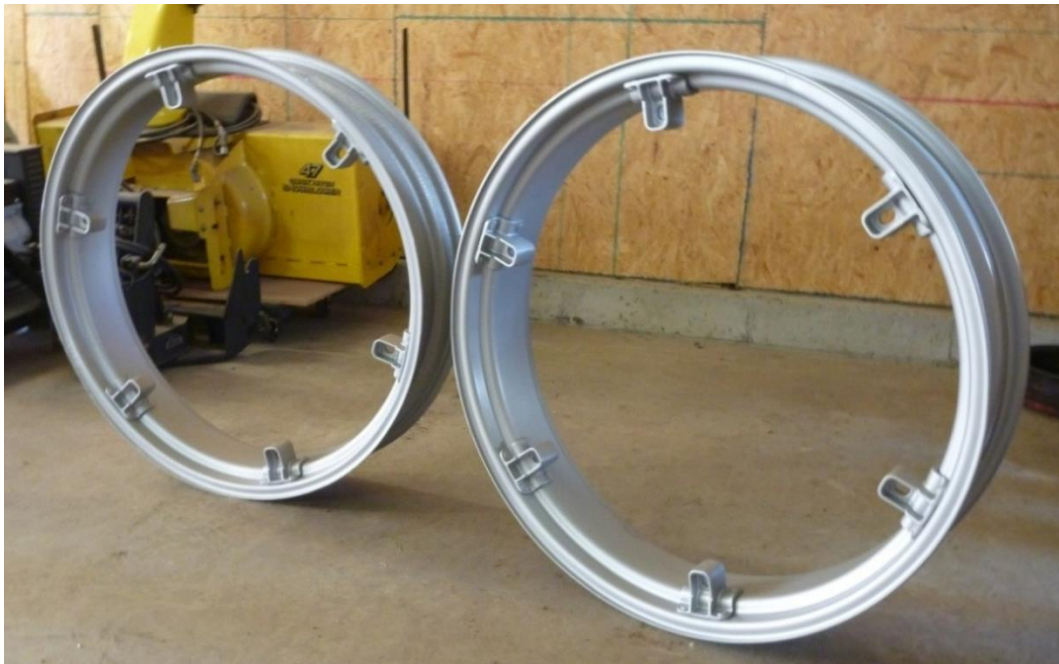
Hours of grinding, sanding, priming, and painting later the rim was complete and ready to be used again. Since the original rim was removed prior to the barn fire of 2009, the original bolts and nuts for the loop rim were lost. Finding ones that have a 1-1/16" head with a 5/8-24 thread (not a standard size) was not an easy task. So, to the lathe I went and made identical nuts and bolts out of 1-1/4" hexagonal bar stock.

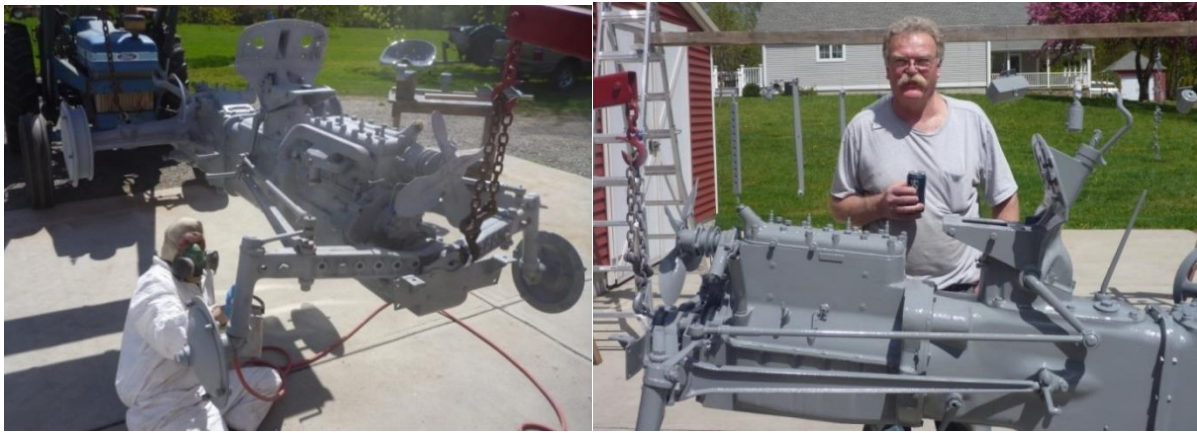
In May of 2013, 9N-90 was ready to be painted, so we prepared for two days prior: This involved sanding down all the parts to 220grit or finer and cleaning off all the dust and other impurities that may have existed. On May 10, we got up early in the morning to set up all the parts outside to be painted after the morning dew settled and after putting on my Tyvek suit and painting mask I went to work. Luckily for me (since I hate painting), completing the job only took a few hours. We left the tractor and parts outside for the rest of the day to allow the paint to harden.

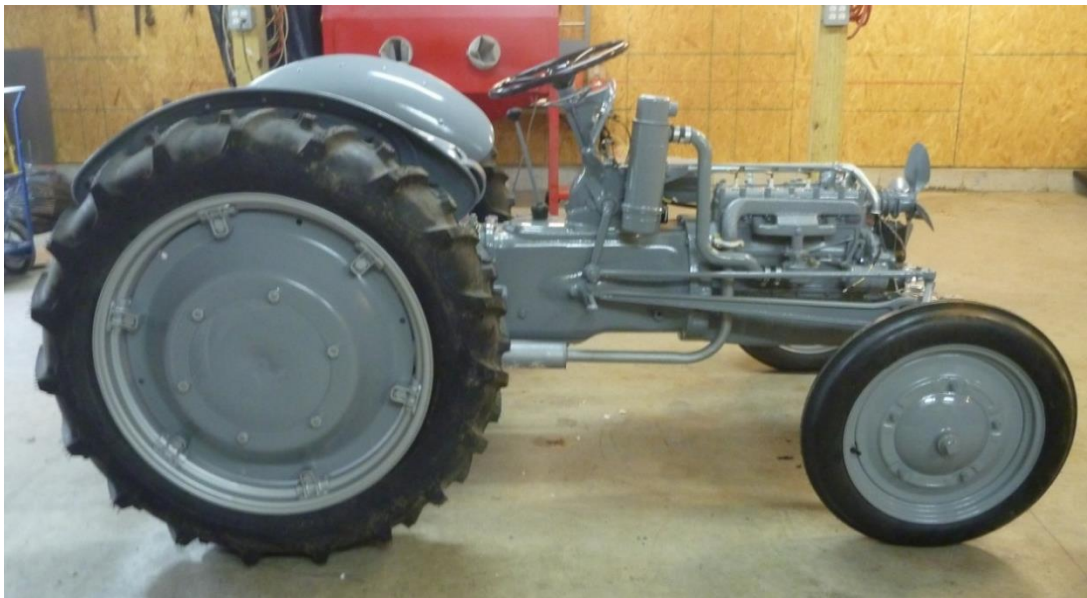
Let me tell you - there is *nothing* like a cold beer at 10:15 in the morning to celebrate reaching this milestone! Later in the day, we moved all the parts back into the barn and began reassembling 9N-90. Remembering how the tractor went back together wasn't as hard as we thought it was going to be - especially since we had taken many pictures of the dis-assembly process and had pictures of other early 9N's, such as SN16 and SN406 , which we used as reference. Late on May 12, 2013, 9N-90 stood on all four of its tires, something that hadn't happened since the fall of 2006.

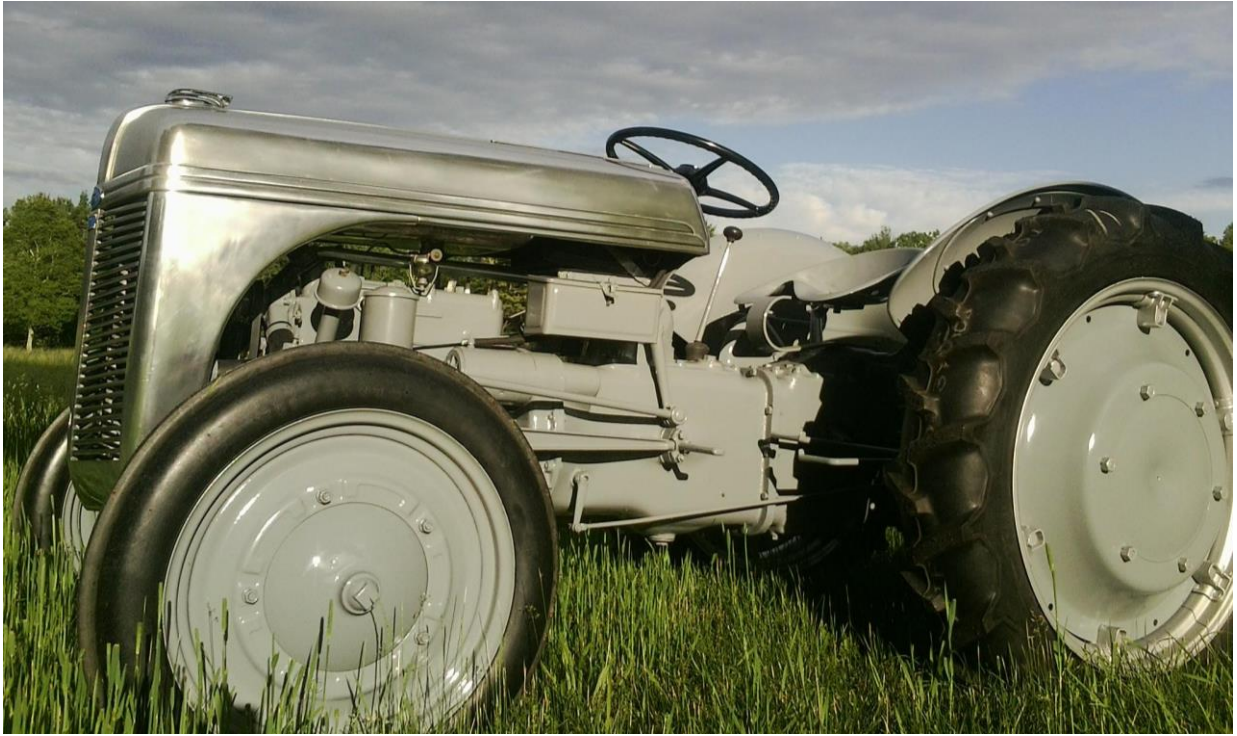
On Saturday, June 8th, 9N-90 was started for the first time since it was put into storage. With a cigar in his mouth and beer in hand, Dad took 9N-90 for a few test laps around the cow pasture. I haven't seen Dad smile this much since I moved out in June of 2004. Although 9N-90 wasn't fully complete at the time, we were able to bring it to the Old Iron Tractor Club show in Woodstock, CT the following day.
