8N Steering Gearbox Lubrication & Oil Filler Plug Locations

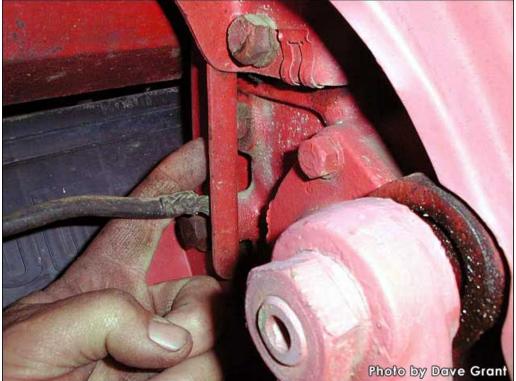
The first oil filler plug on the new steering gearbox was an 1/8 pipe plug located behind the instrument panel support bracket on the upper left-hand side of the steering gearbox. As seen in the picture below, it was nearly

impossible to get to.

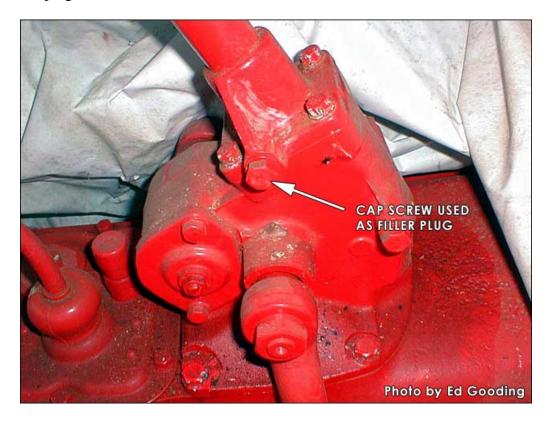
On April 20, 1951, the first oil filler plug was discontinued. The hole is filled with metal, completely sealing it. At this time the cap screw on the right hand side, which secures the instrument panel support to the steering housing, was used as the filler plug.

The housing should always be filled to the level of the cap screw hole to insure that the top bearing (8N-3571), receives lubrication. Fill when the level falls below the cap screw.
