# 8N Hat Rim Repair

By Steve Acker 10-4-11

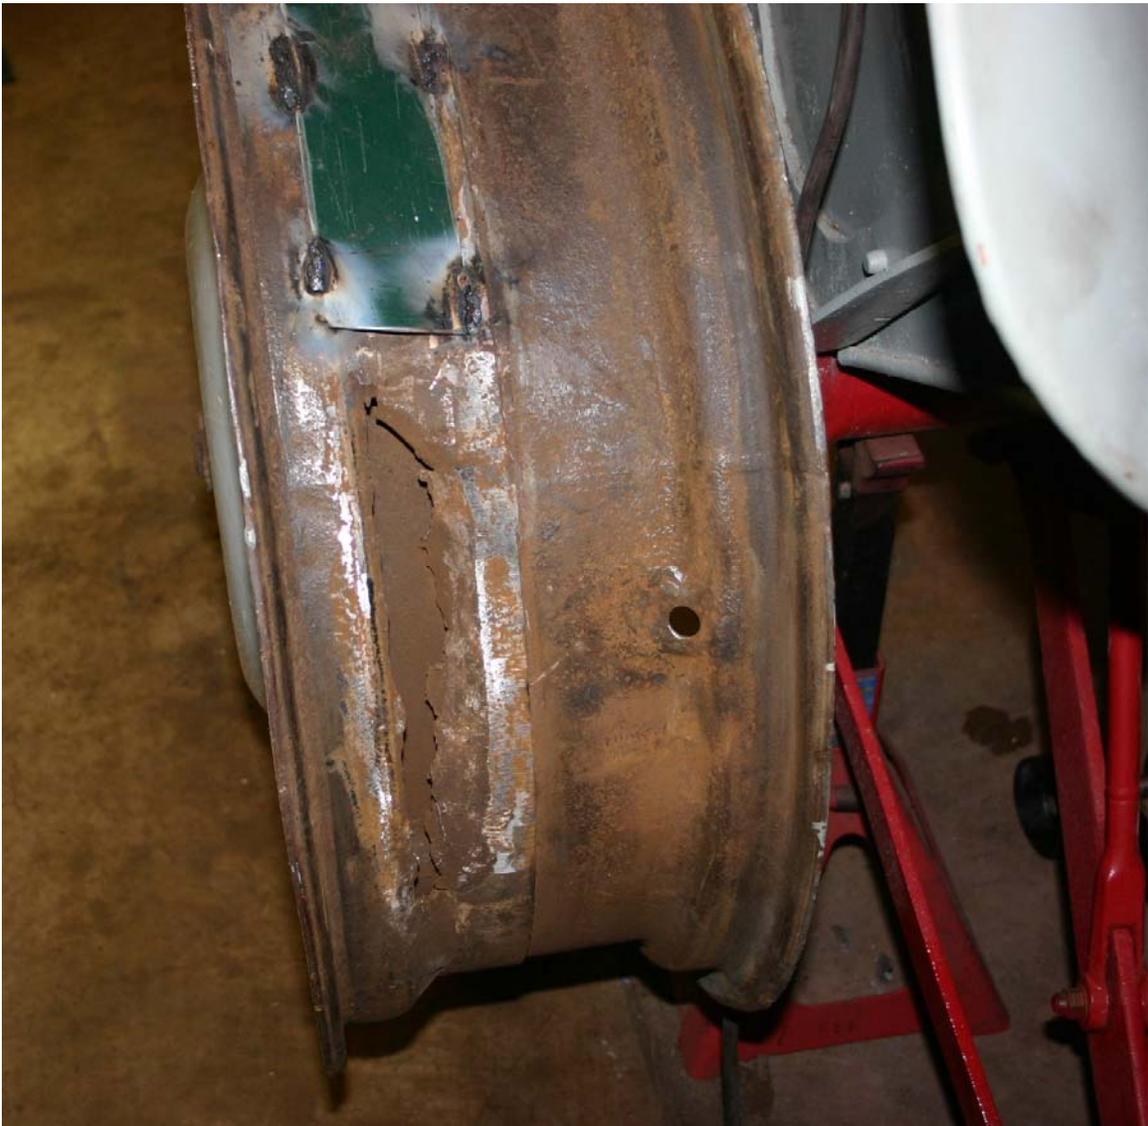
I started by wire brushing the wheel to remove most of the rust. I then hammered in all the rusted spots to find any remaining weak areas. There were plenty. More than half the rim was rusted through. While this may not affect the strength very much it is required to support the inner tube. I decided to photograph this after I started, so the full extent of the rust damage is not visible.

This is part of the rust damage to the wheel:

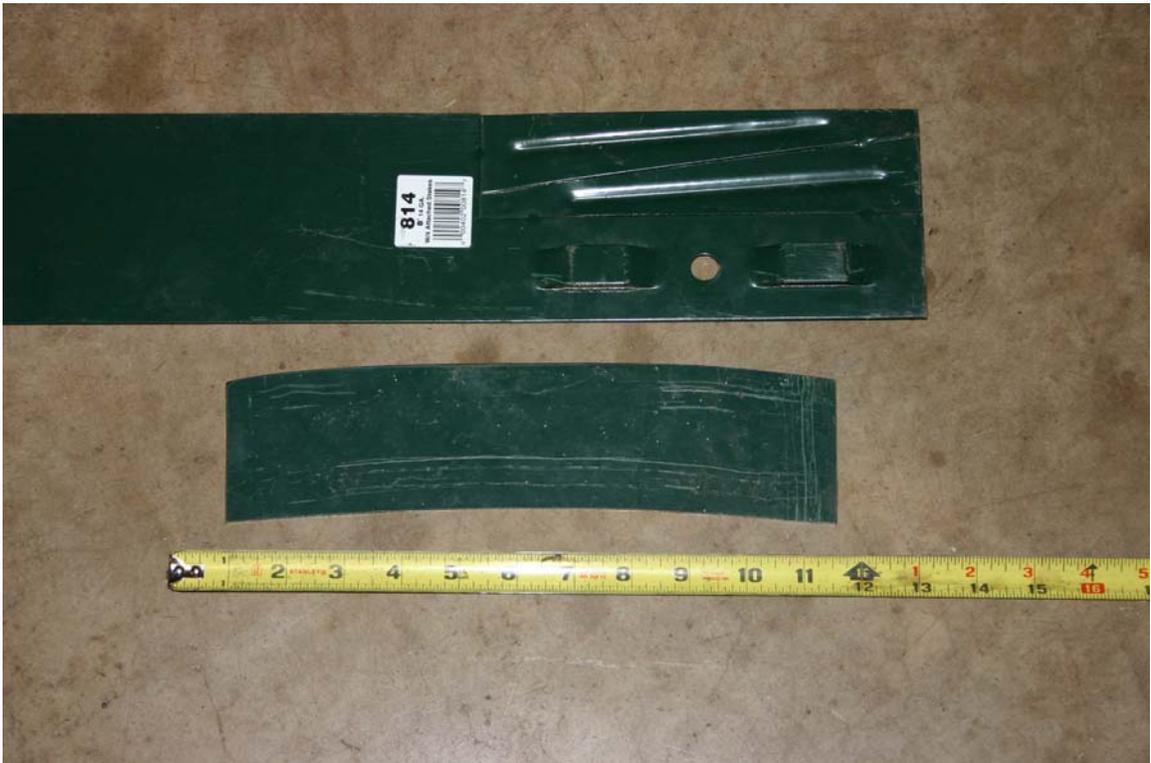
The curved segment and the lawn edging used to make the repair pieces:

I looked for some suitable metal and found a lawn edging strip from Home Depot. I cut a strip the right width but it would not fit around the rim the way I wanted to position it. It dawned on me that the repair segments would have to be curved to wrap around the wheel as I visualized the repair. Once I realized this I then took a piece of cardboard and started cutting out a curved section that would line up properly with the wheel when it was in place. I used trial and error to find a curvature that worked.

This piece of cardboard was traced onto the lawn edging. The segment was cut out on a vertical band saw. I bent the pieces in a bench vise to match the curvature of the wheel. The areas of the wheel that would be welded were cleaned up to bare metal with a small hand held grinder. The paint at the edges of the lawn edging strip was ground off.

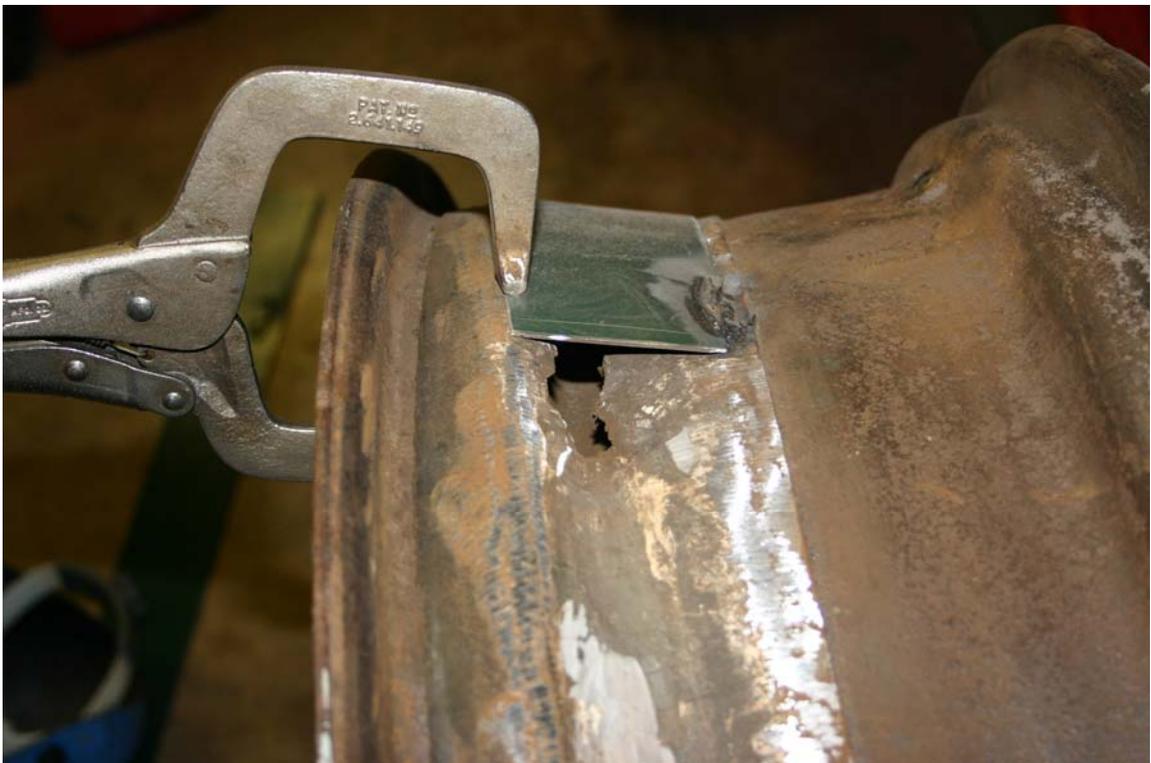
Clamping the segments in place for welding:

Welding was done with 3/32nds inch 6011 at 40 amps AC. Once the first piece was in place the end of each subsequent piece was ground down so that they would butt up properly to the preceding piece. After the last piece was installed the ends of the run were hammered down to meet the wheel and welded. Welds and splatter were then cleaned up with the grinder.

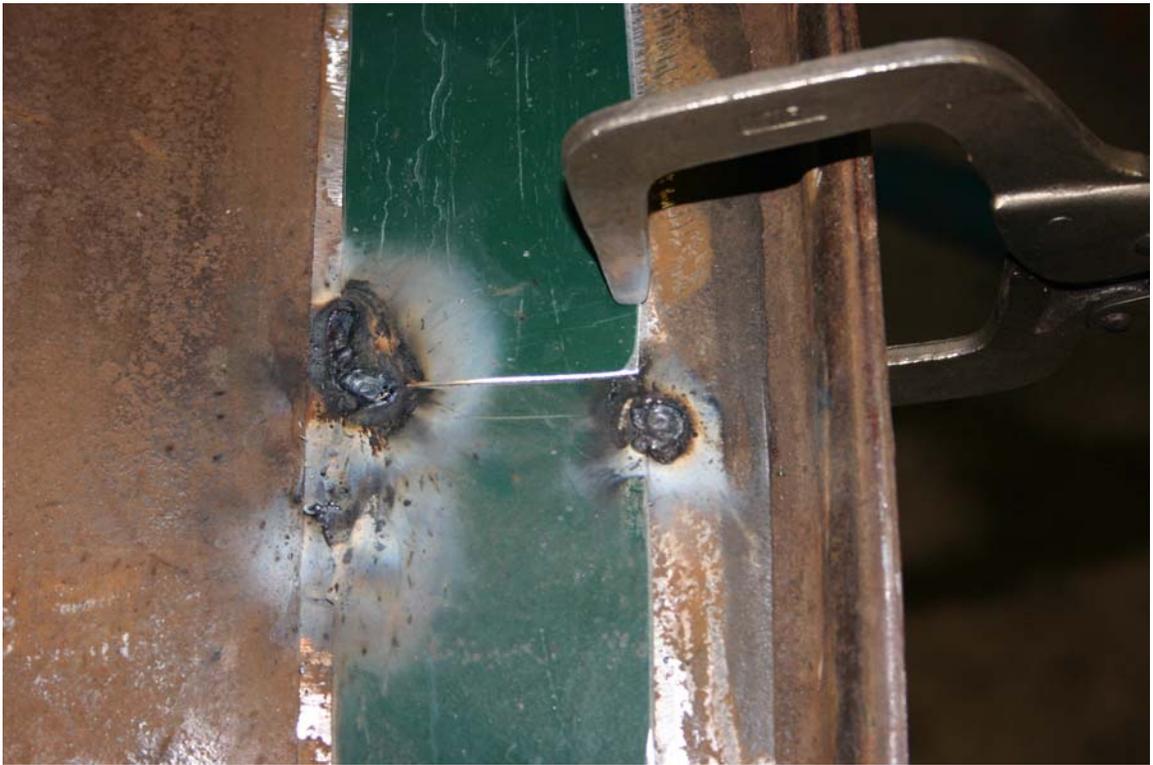
Joining the segments end to end:

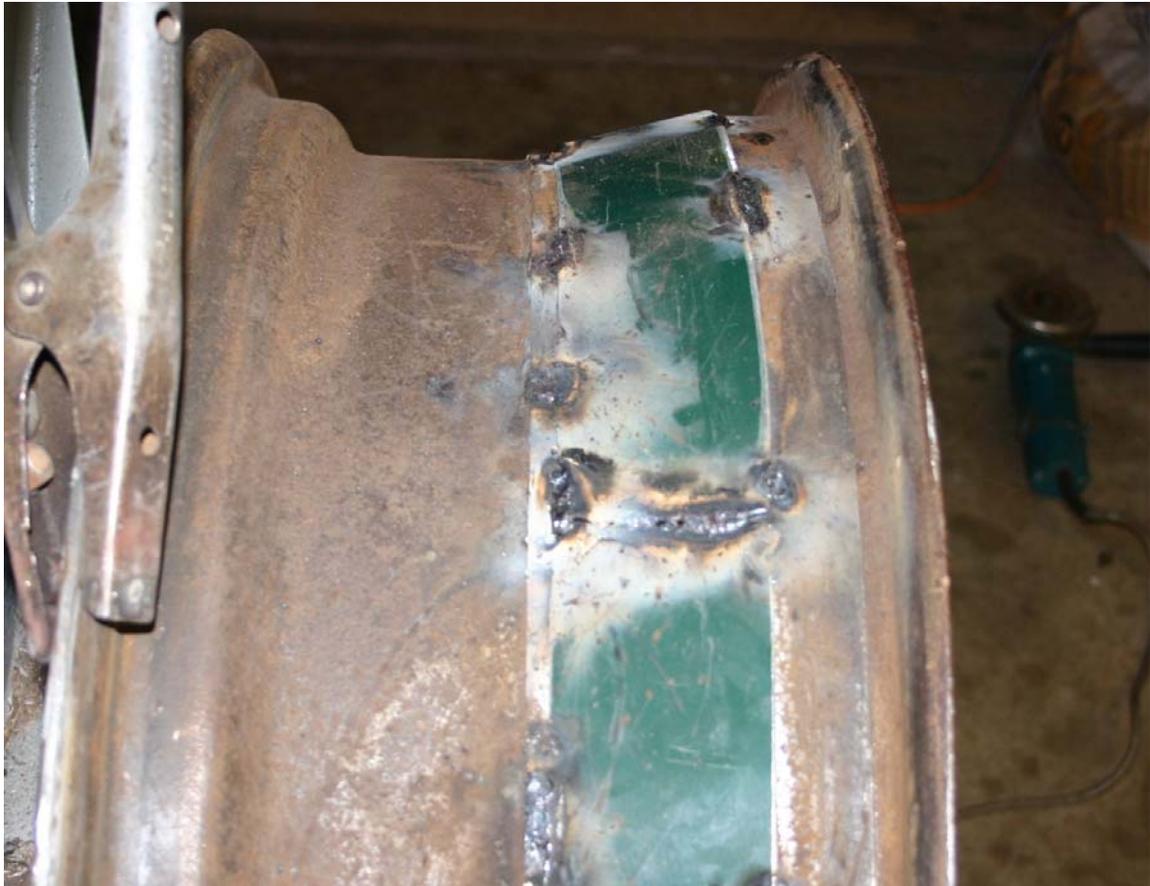
Multiple patch segments in place:

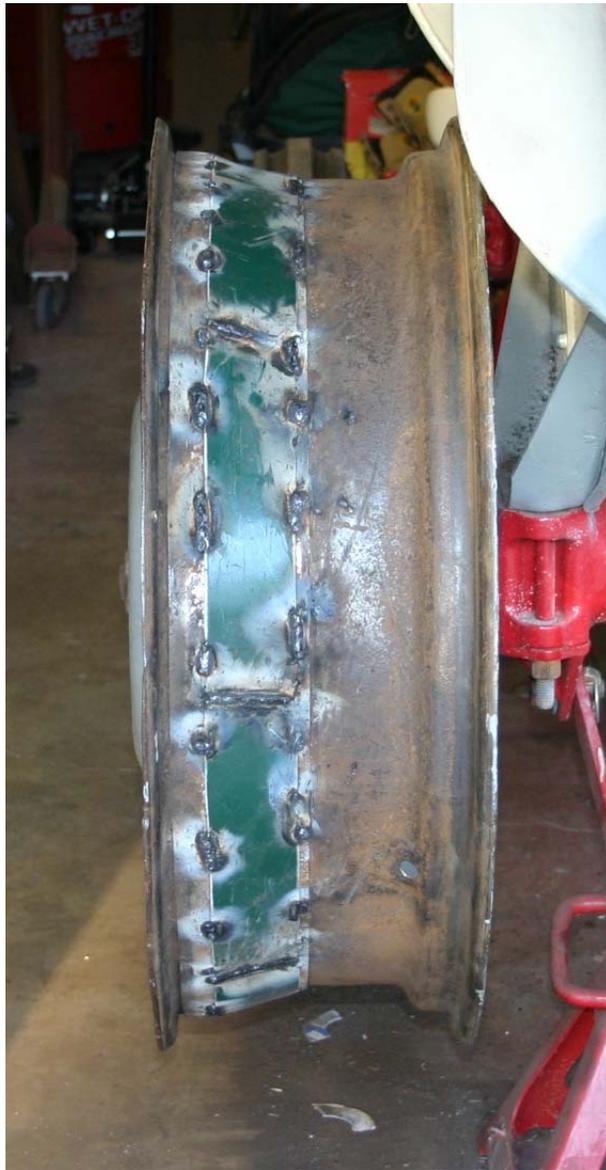
Almost done installing the segments:

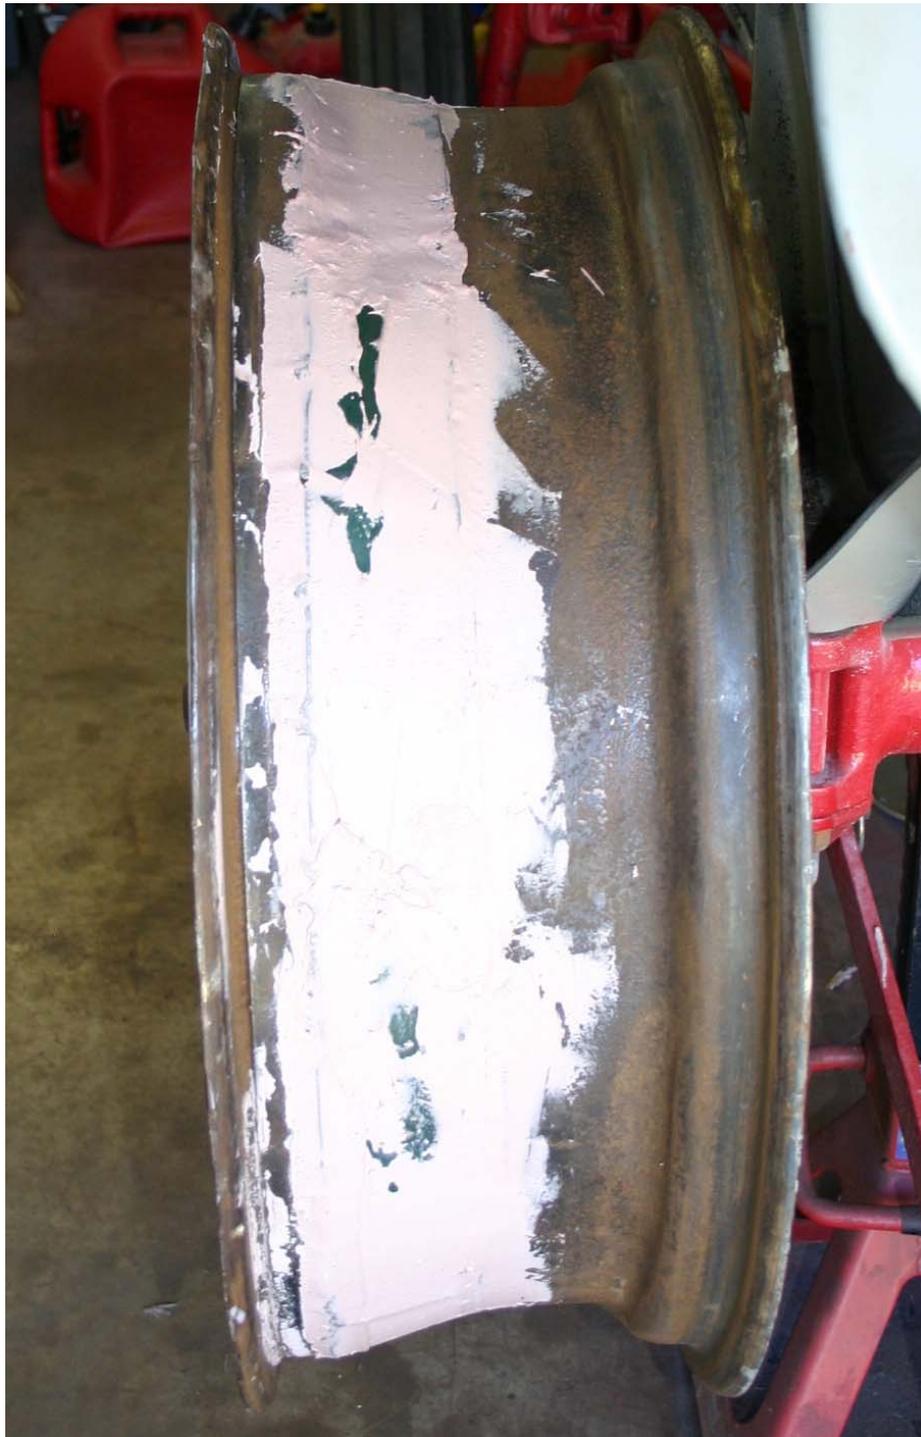
After body putty, ready for final sanding and painting:

After this was done body putty was used to smooth out the edges of the work. This was then sanded down. The inside of the wheel was painted with primer. The wheel was then put back in service.
