Replacing the PTO Yoke on Your Ford Posthole Digger

By: Bill Corder
Sanford, North Carolina

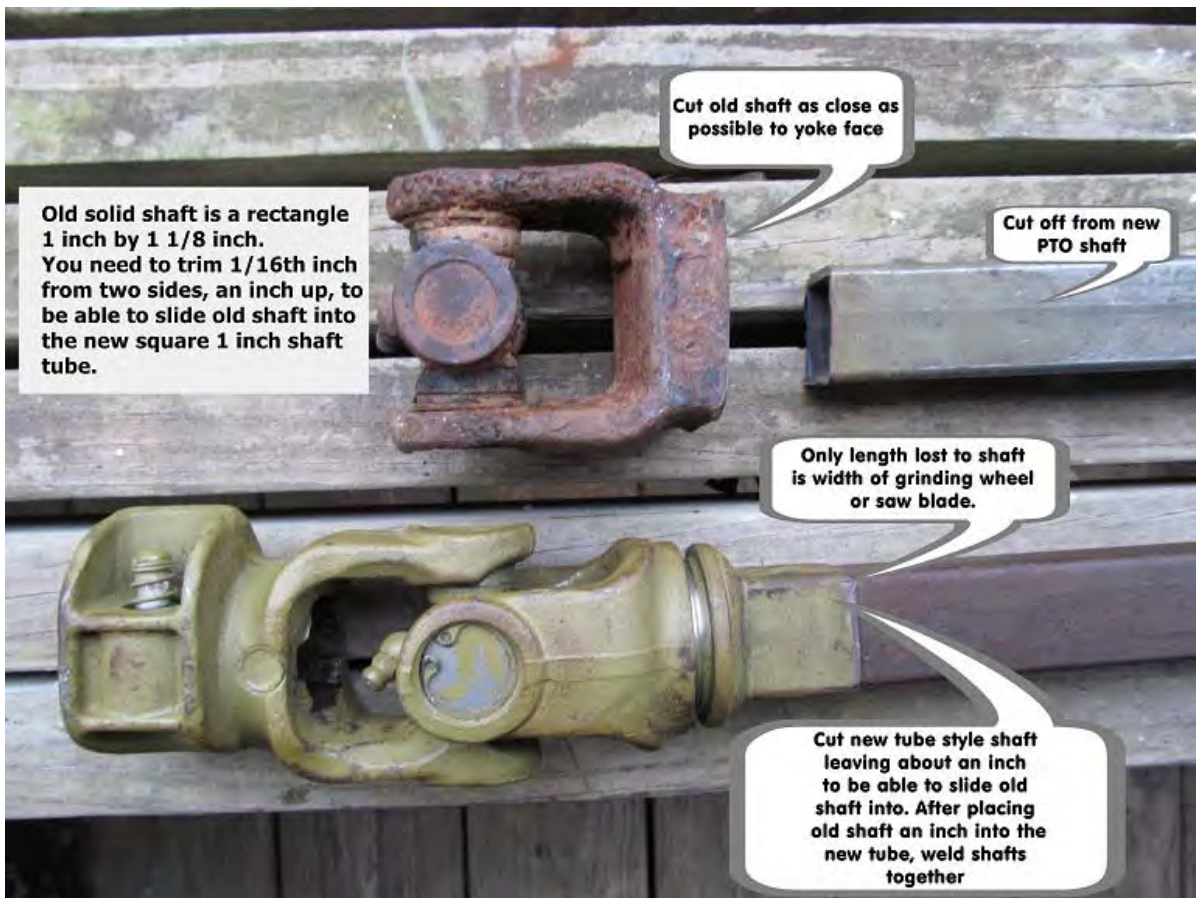
We purchased a Ford Post Hole Digger, Model 22-63, from our state salvage location. This digger was missing the PTO yoke that attaches to the PTO shaft on the tractor. Should have been an easy fix, but we found out differently! Since the Ford posthole digger was manufactured around 1963 or 64, it was American made and used inch measurements. The only PTO yokes available around here are Euro design, which are metric.

- The solid shaft of the Ford posthole digger is a rectangle shape, 1 inch by 1-1/8th inch. The euro shaft has a 1 inch square (inside measurement) tube.
- Cut the euro tube about an inch behind the PTO yoke.
- Then cut the old yoke off the Ford shaft as close to the yoke as possible.
- Since the old shaft is a rectangle, you need to trim 1/16 inch from two sides, making an inch of the old shaft 1 inch square.
- Place the old rectangle shaft inside the new tube shaft and weld together.

We found the second hand euro shaft at a rental tool location for \$20.00.
